**TECHNICAL REPORT NO. 76-8**

**SEMIANNUAL REPORT, PROJECT T/4703  
SPECIAL DATA COLLECTION SYSTEMS**

**JANUARY THROUGH JUNE 1976**

**TELEDYNE  
GEOTECH**

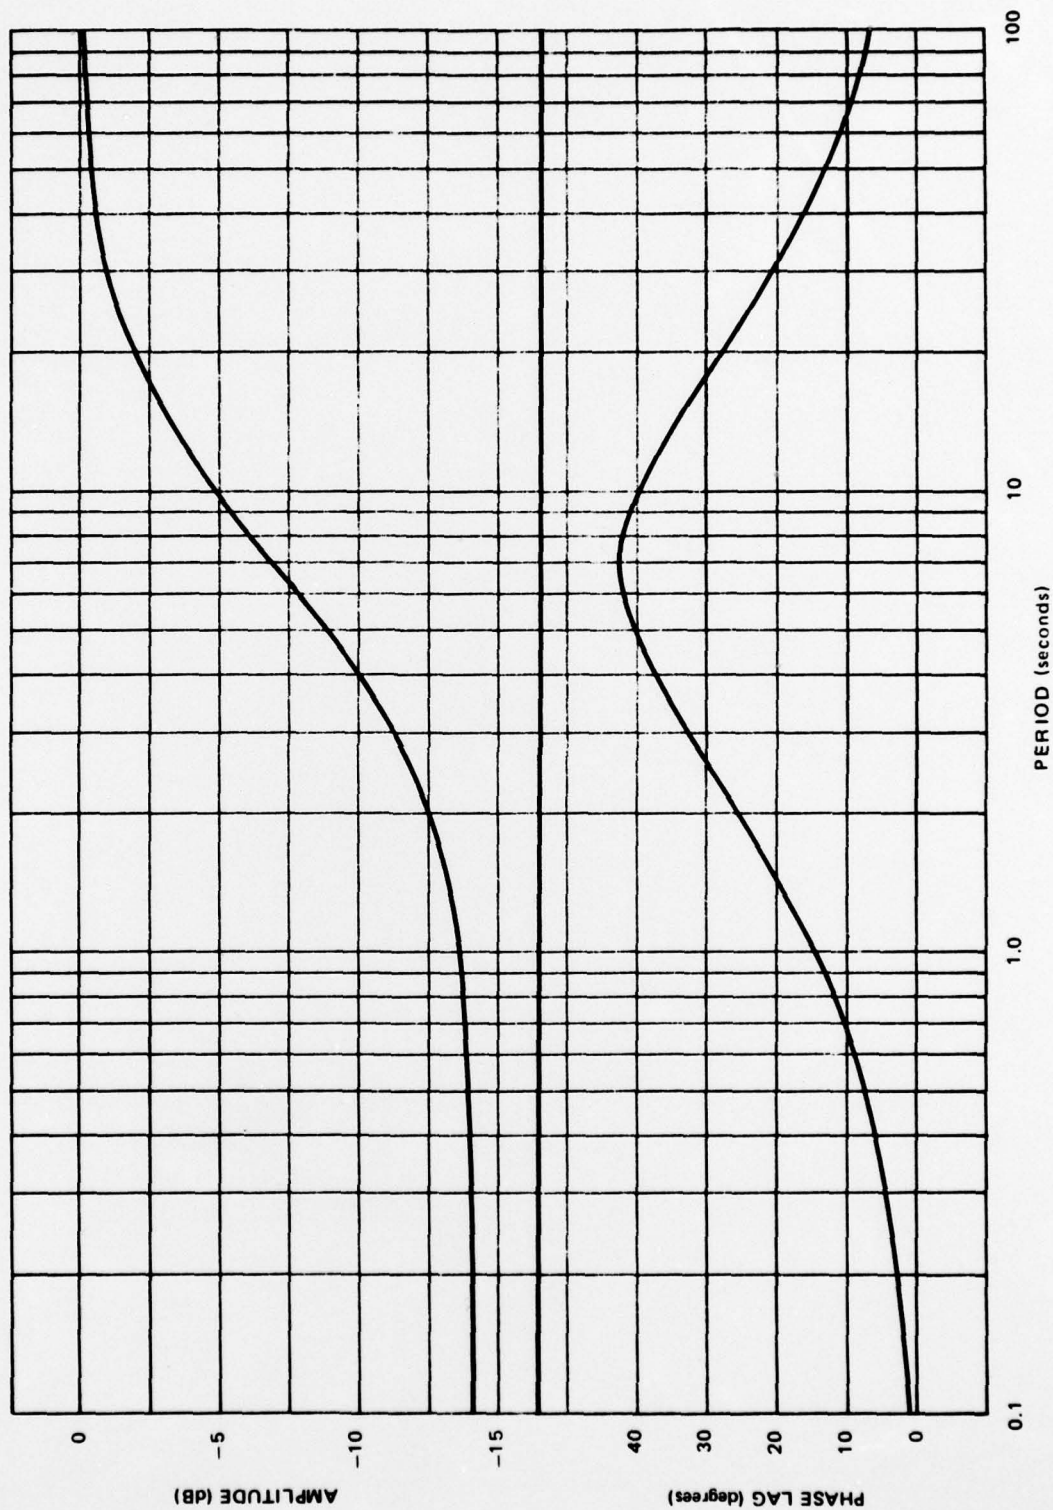
The modification consists of replacing two resistors and one capacitor in each of the three line drivers in the KS electronics. Figure 2 shows the amplitude and phase response of this filter. The overall effect of this modification is to shift the normalized LP frequency response slightly toward the longer periods. The SP response is attenuated 12 to 14 dB and has slightly more gain at the longer periods. The appendix shows the total system amplitude and phase responses in tabular form for both the original and the modified cases.

Figure 2. Amplitude and phase responses of the modified Model 36000 line driver filter G9135

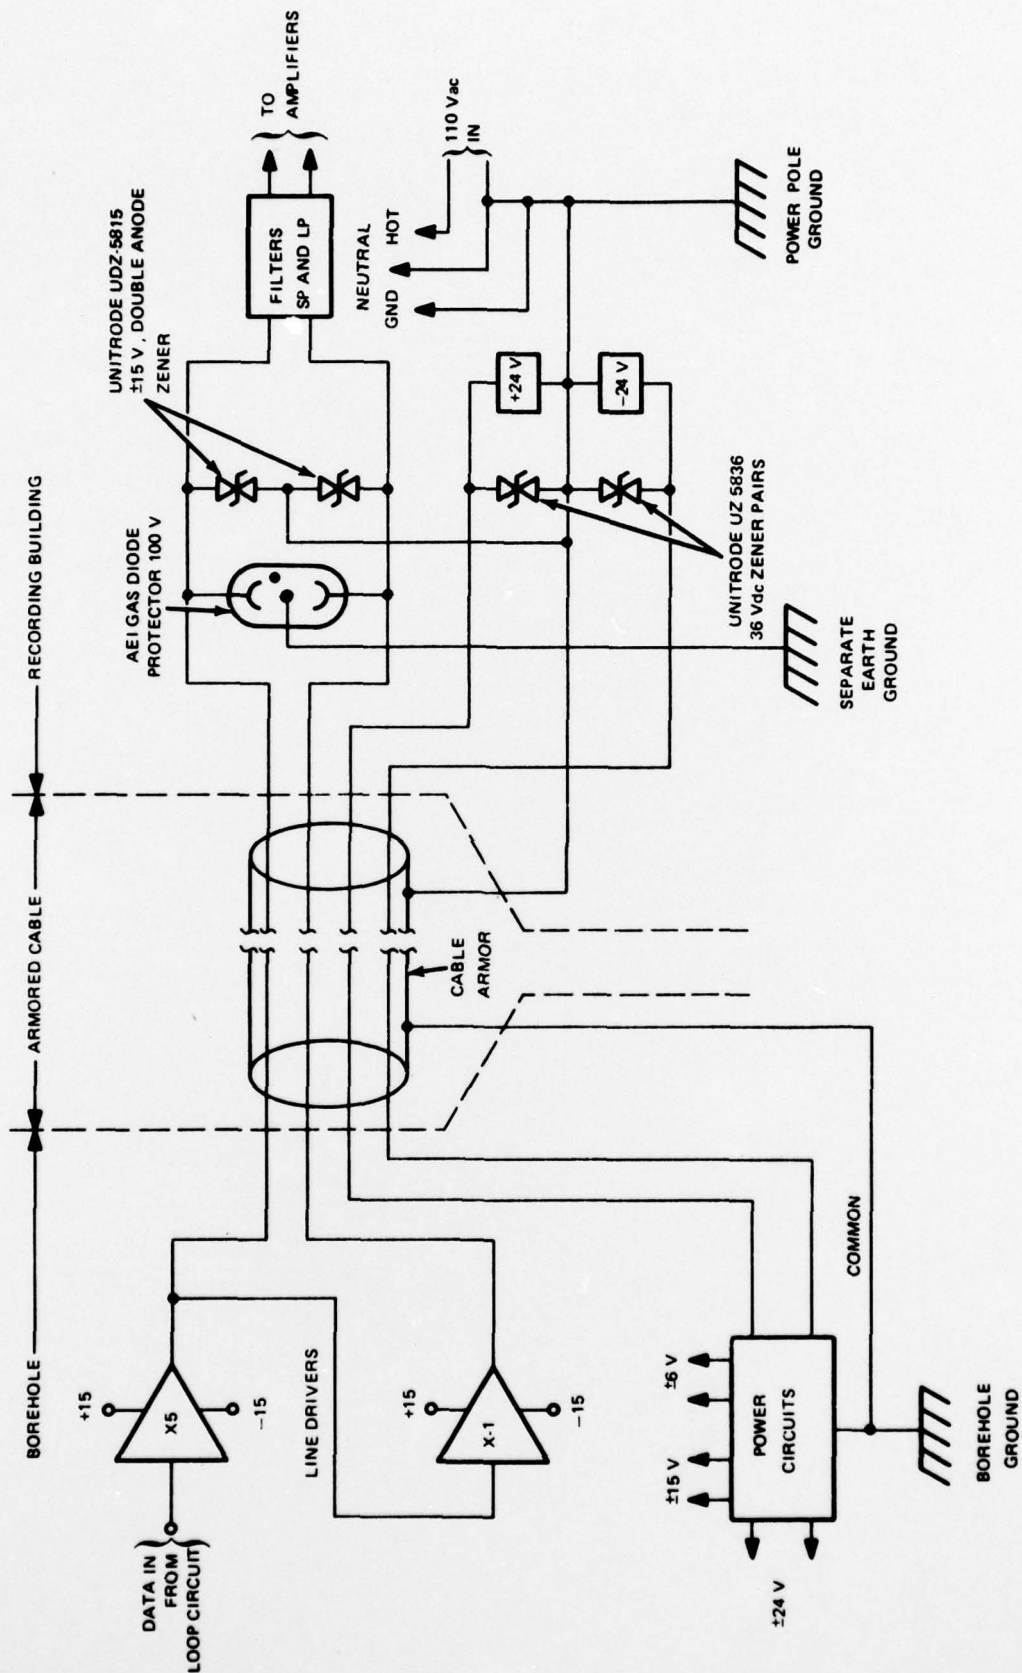
G 9136

On arrival in Garland, the damaged system was immediately inspected in order to determine the extent of the damage and to determine an explanation for the failure. The electronics section was found to have six of the eight line driver operational amplifiers shorted. When these were replaced, all digital circuitry and power circuits operated normally. Preliminary checks of the mechanical section showed that no major damage was done to the modules. At the end of this period, the electronics section had not been fully tested to determine whether there was any further damage which could cause system noise. The complete system will be fully tested to normal specifications during July and August.

Figure 3 is a sketch showing the basic circuitry with its lightning protection. Note that each data circuit is protected both by double anode Zeners from both sides of the line to signal common and by an AEI gas diode protector whose common terminal is connected to a separate earth ground near the protector box. The Zener diode protection on the dc power lines was added as a result of lightning damage to the downhole power supply at Pinedale, Wyoming in 1974. Analysis of the failure at FN-WV has lead to the following conclusions:

- a. The AEI protector probably did not fire because its 100 V + firing voltage would have resulted in far worse damage than that experienced;
- b. The lightning surge did not come through the +24 V power line to the KS because the power supply was undamaged as was other circuitry which it supplies;
- c. Damage to the line driver operational amplifiers resulted from excessive voltages on their output terminals;

Figure 3. Simplified schematic diagram of basic KS data and power circuitry showing lightning protection devices as installed at Franklin, West Virginia and Houlton, Maine sites

d. High voltage pulses did not pass through the filters because none were damaged;

e. Damage to the line drivers most likely occurred due to conduction of the lightning protection diodes. It is theorized that the lightning caused a high voltage potential between the borehole and power pole grounds and neither the earth nor the cable armor had sufficiently low resistance to keep it within safe limits; the UDZ-5815 Zeners conducted heavily when the uphole ground potential exceeded 15 volts, allowing the voltage on the operational amplifier outputs to exceed maximum ratings.

As a result of these findings, the following will be implemented and is recommended for all KS sites:

- a. Remove all lightning protection devices on the four KS data lines, because filter circuits provide adequate isolation from external sources;
- b. Retain diode protection on power and calibration lines leading downhole;
- c. Connect a heavy ground line (#4AWG copper or heavier) between the borehole casing and the common ground point at the recording facility. Also, ground the cable armor to the bus at the wellhead.

It is thought that the lightning susceptibility of the KS system is increased at installations such as FN-WV where system power is supplied by commercial ac power. At installations where power is generated at the site (such as by a thermoelectric generator), it is likely that lightning damage would not have occurred. Geotech personnel familiar with the KS installations at Albuquerque. (SRO) and Iran (ILPA) have indicated that the above procedures are being generally followed. However, it has been suggested that grounding at the ILPA be improved by connecting both the surface conduit and the cable armor to the wellhead.
